<b>PHILIPS HEALTHCARE</b>	<b>Product Recycling Passport</b>	Page 1 of 6
-------------------------------	-----------------------------------	-------------

<b>Product name:</b>	<b>Brilliance iCT Bariatric Patient Support</b>	
<b>Identification code(s)</b>	<b>4535 674 80191</b>	
<b>Total weight (in Kg)</b>	<b>395</b>	
<b>Producer/ Manufacturer</b>	Name company:	Philips Medical Systems
	Address:	595 Miner Road Highland Heights, Ohio
	Zip code:	44143
	Country:	United States of America

Title: Recycle Passport Brilliance iCT Bariatric Patient Support  
Recycling Passport Number: 4535 675 34241 Rev: B

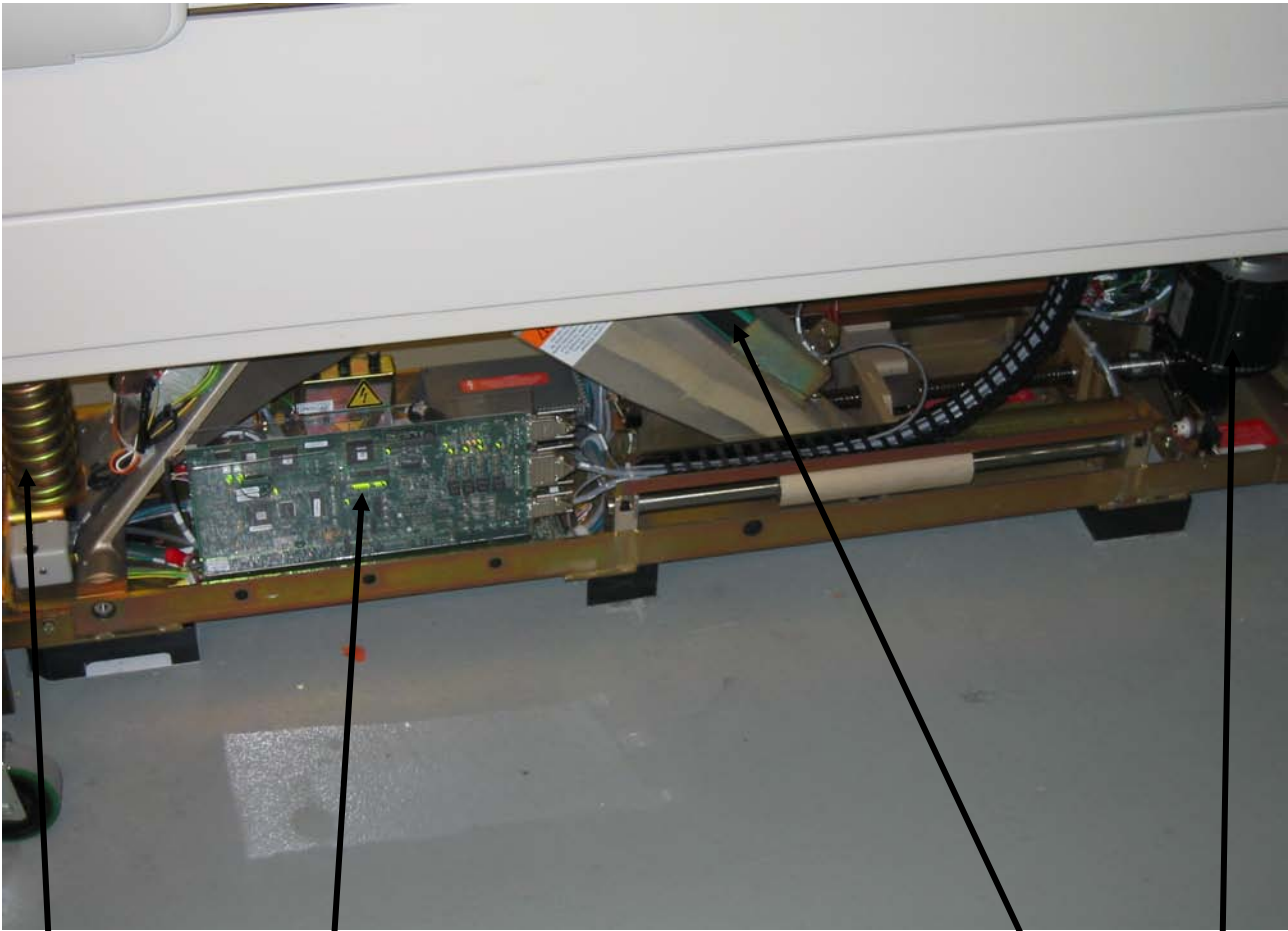
Figure 1: Right Side Couch

Removal of Motor: Couch will drop when motor is removed.	Figure 1 (1)
	Green Safety Block: When removed, couch may collapse.	Figure 1 (3)
	Giant Spring: Potential energy hazard.	Figure 1 (4)
<b>Fluids / Gases</b>

<b>Substances:</b>	<b>Location</b>
	Printed Circuit Boards	Figure 1 & 2 (2)
<b>To be Removed</b>

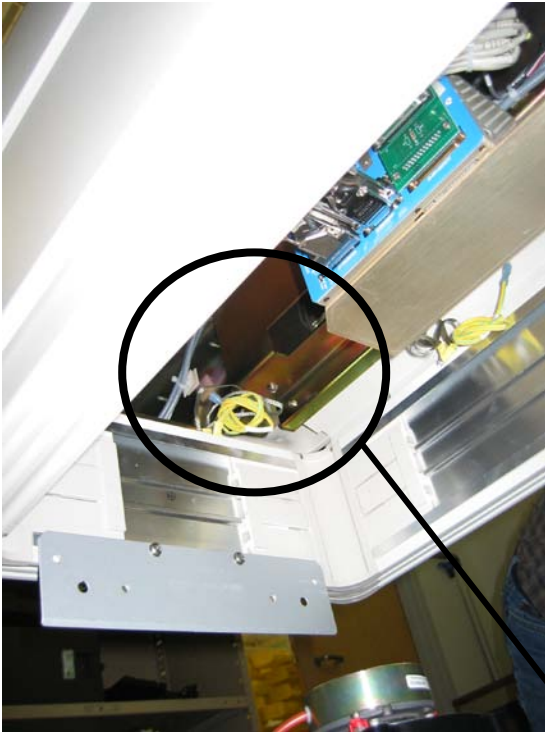
**Figure 3: Underneath Rear of Sub-frame**

<b>Items:</b>	<b>Location</b>
	Pressure Springs: Must drill 2mm hole to relieve pressure before disposing of springs.	Figure 3 (5)
<b>Batteries</b>
