PHILIPS HEALTHCARE	Product Recycling Passport	Page 1 of 3
-------------------------------	-----------------------------------	-------------

Product name:	Sparq Medical Diagnostic Ultrasound Equipment	
Identification code(s)	989605394911	
Total weight (in Kg)	71.13 kg	
Producer/ Manufacturer	Name company:	Philips Ultrasound
	Address:	22100 Bothell Everett Highway, Bothell, WA
	Zip code:	98012
	Country:	USA

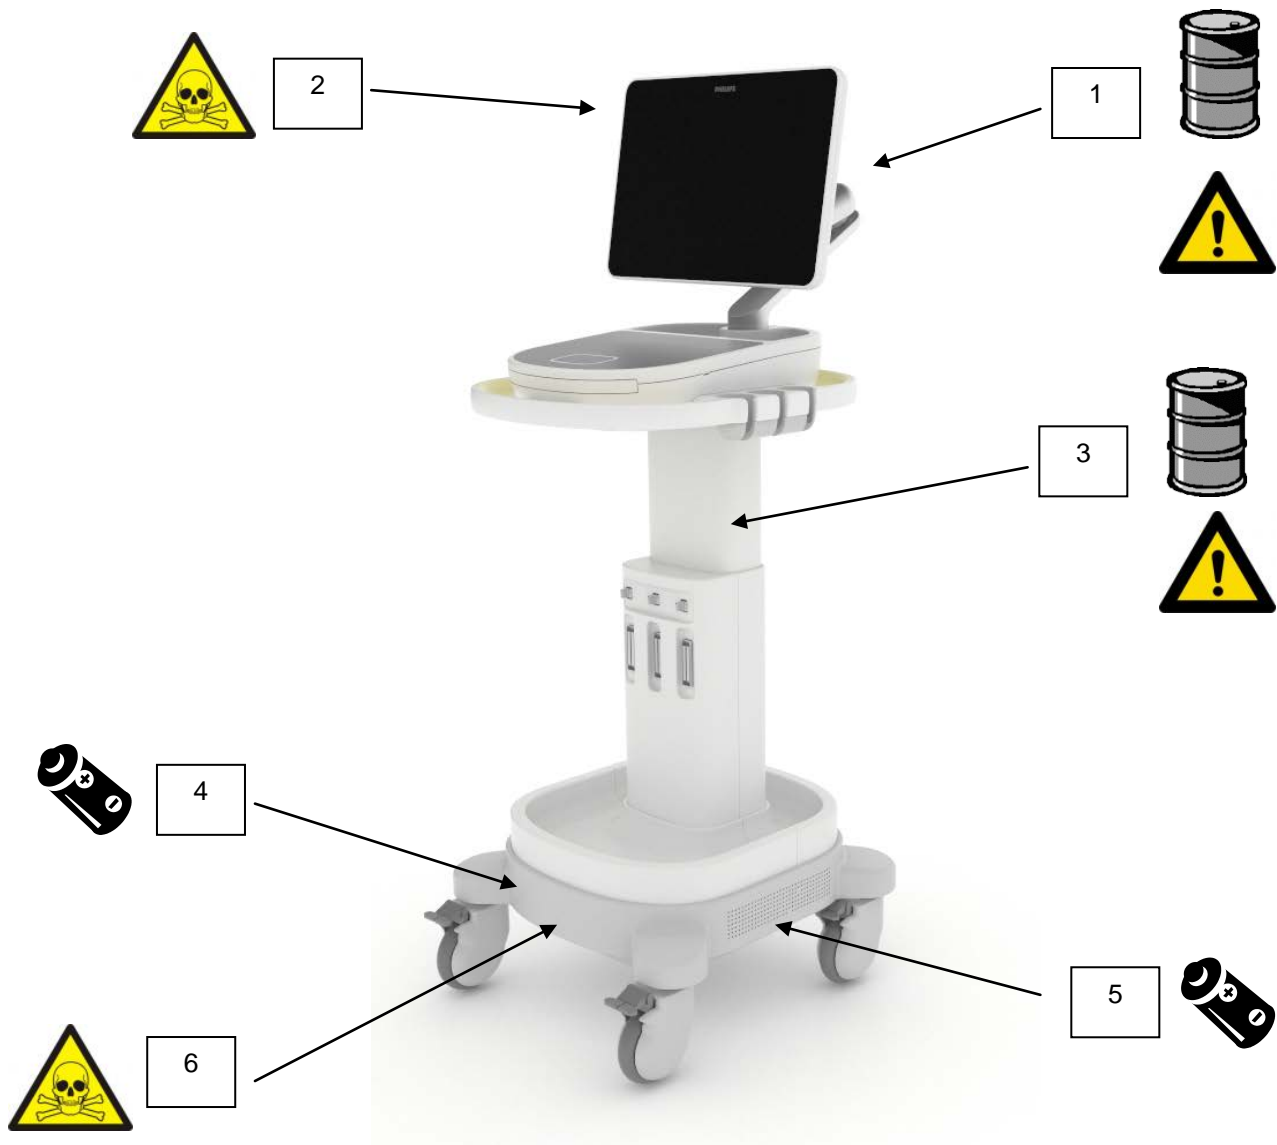
Figure 1: Sparq

Arm gas strut under pressure	Figure 1 [1]
	Vertical articulation gas strut under pressure	Figure 1 [3]

Fluids / Gases	Oil and Nitrogen gas: in gas strut in Articulation Arm mechanism. Do not drain oil with device under pressure	Figure 1 [1]
	Oil and Nitrogen gas: in gas strut in vertical articulation mechanism. Do not drain oil with device under pressure	Figure 1 [3]

To be Removed	Battery in System. Button cell on Mainboard.	Figure 1 [4]
	Battery in System. Four (x4) LiON Batteries in the Power System	Figure 1 [5]

To be Removed	Mercury (Hg) – Monitor contains mercury in the backlight lamps.	Figure 1 [2]
	Lead (Pb) -- Contains lead in PCB's and solder.	Figure 1 [6]

Show locations of materials mentioned on the previous sheet. (Picture information)
