Product name:	MD Eleva (MultiDiagnost Eleva)	
Identification code	708-032	
Total weight (in Kg)	2410 kg (approximately; dependent on specific configuration)	
Producer/ Manufacturer	Name company:	Philips Medical Systems
	Address:	Veenpluis 6
	Zip code:	5684 PC Best
	Country:	Netherlands
	Electronic info:	http://www.healthcare.philips.com/us/about/sustainability/recycling/

Title: Recycling passport MD Eleva 708-032

DocID: XDR054-090791

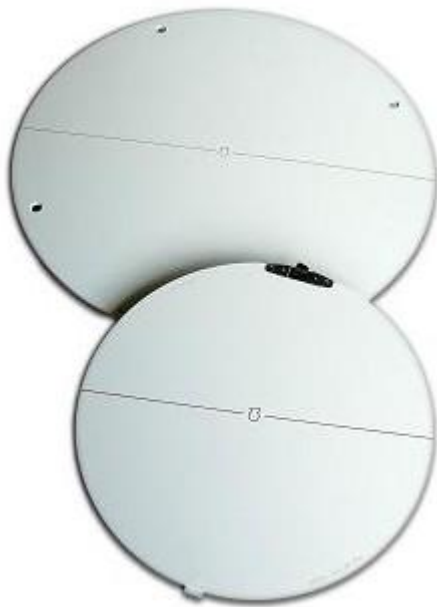
To be Removed	Substances:	Location
	Lead (Pb 99,5%)	Enclosed between cover plates

Example larger and smaller grid (only 1 present in system)

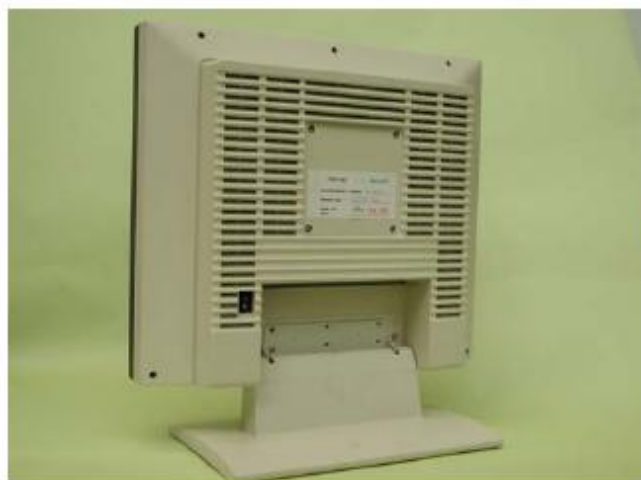
LCD screen FIMI MML1801-IP1P / 9919-320-5067x | PAGE 2 of 2

To be Removed	Substances:		Location
	Type	Quantity	
	Cd	0	
	Hg	21 mg max. (Mercury is present in the backlight lamps)	Next figure (1)
	Pb	Lead is present in the soldering process of PCBs	Next figure (2.x)
	Cr ⁶⁺	0	
	PBB	0	
	PBDE	0

Material		
Fe	6 kg	-
Al	0	-
Cu	0.11 kg	Cables
Plastics	1.5 kg	-
Boards ($S^2 > 10\text{cm}^2$)	96 cm ² / 260 g 320 cm ² / 230 g 144 cm ² / 67 g 100 cm ² / 50 g 46 cm ² / 40 g	S.M.P.S. (item 2.1 in the picture) Logic Board (item 2.2 in the picture) Inverter (item 2.3 in the picture) LCD Driver (item 2.4 in the picture) PCB Light Sensor (item 2.5 in the picture)
LCD	3.97 kg	18"

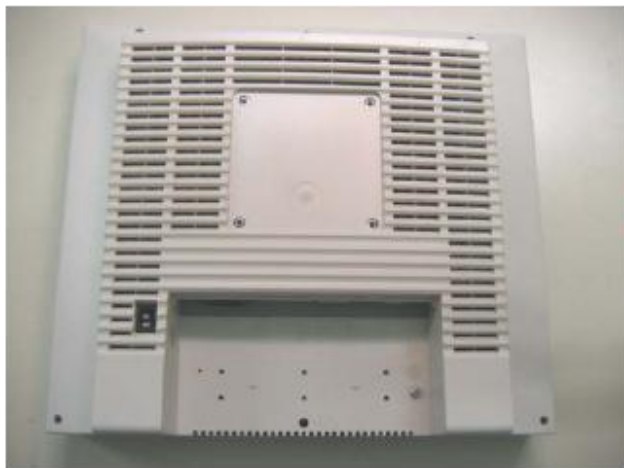
LCD screen FIMI MML1802-IP10 / 9919-320-5069x

</div> <div>To be Removed</div>	Substances:		Location
	Type	Quantity	
	Cd	0	
	Hg	21 mg max. (Mercury is present in the backlight lamps)	Next figure (1)
	Pb	Lead is present in the soldering process of PCBs	Next figure (2.x)
	Cr ⁶⁺	0	
	PBB	0	
	PBDE	0

Material		
Fe	2.3 kg	-
Al	0	-
Cu	0.1 kg	Cables
Plastics	1 kg	-
Boards (S ² > 10cm ²)	96 cm ² / 260 g 320 cm ² / 230 g 144 cm ² / 67 g 100 cm ² / 50 g 46 cm ² / 40 g	S.M.P.S. (item 2.1 in the picture) Logic Board (item 2.2 in the picture) Inverter (item 2.3 in the picture) LCD Driver (item 2.4 in the picture) PCB Light Sensor (item 2.5 in the picture)
LCD	3.9 kg	18"

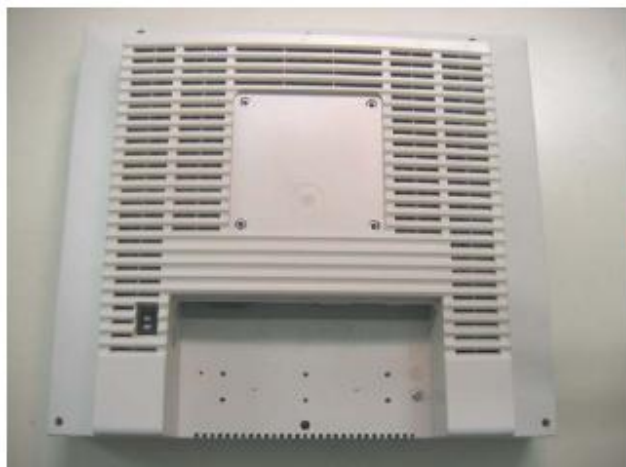
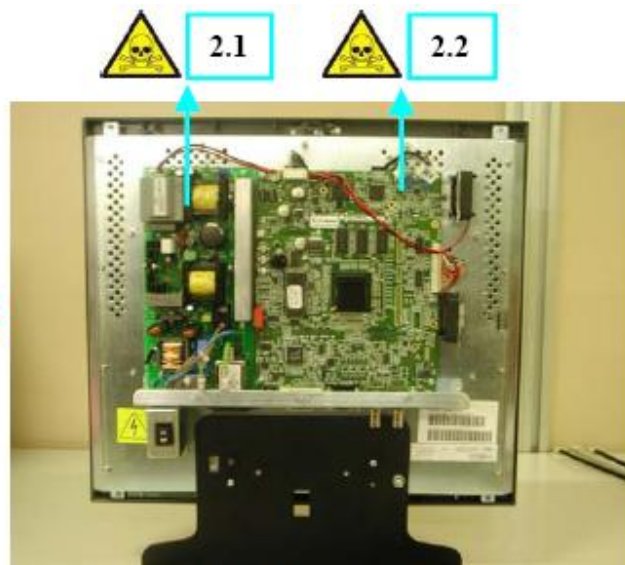
LCD screen FIMI MCL1802-IP10 / 9919-320-5072x

To be Removed	Substances:		Location
	Type	Quantity	
	Cd	0	
	Hg	21 mg max. (Mercury is present in the backlight lamps)	Next figure (1)
	Pb	Lead is present in the soldering process of PCBs	Next figure (2.x)
	Cr ⁶⁺	0	
	PBB	0	
	PBDE	0

Material		
Fe	2.3 kg	-
Al	0	-
Cu	0.1 kg	Cables
Plastics	1 kg	-
Boards (S ² > 10cm ²)	96 cm ² / 260 g	S.M.P.S. (item 2.1 in the picture)
	320 cm ² / 230 g	Logic Board (item 2.2 in the picture)
	144 cm ² / 67 g	Inverter (item 2.3 in the picture)
	100 cm ² / 50 g	LCD Driver (item 2.4 in the picture)
	46 cm ² / 40 g	PCB Light Sensor (item 2.5 in the picture)
LCD	3.9 kg	18"

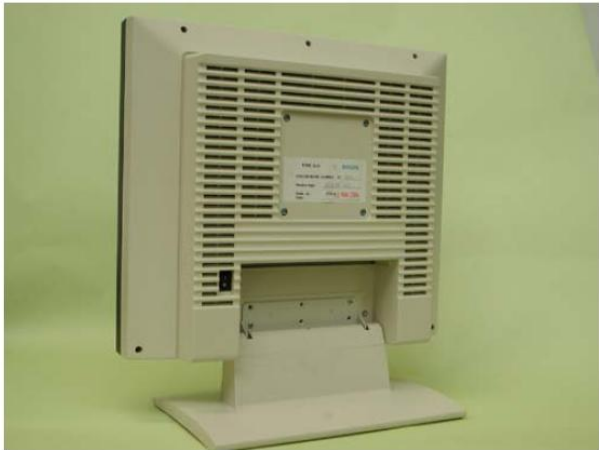
LCD screen PHILIPS FIMI MCL180L / 9919-320-5089x

</div> <div>To be Removed</div>	Substances:		Location
	Type	Quantity	
	Cd	0	
	Hg	21 mg max. (Mercury is present in the backlight lamps: 3.5 mg x 6 lamps)	Next figure (1)
	Pb	Lead is present in the soldering process of PCBs	Next figure (2.x)
	Cr ⁶⁺	0	
	PBB	0	
	PBDE	0

Material		
Fe	6.0 kg	(3.4 kg in the pedestal)
Al	0	
Cu	0.1 kg	Cables
Plastics	1.5 kg	(0.4 kg in the pedestal)
Boards (S ² > 10cm ²)	96 cm ² / 260 g	S.M.P.S. (item 2.1 in the picture)
	320 cm ² / 230 g	Logic Board (item 2.2 in the picture)
	144 cm ² / 66 g	Inverter (item 2.3 in the picture)
	72 cm ² / 54 g	LCD Driver (item 2.4 in the picture)
LCD	3 kg	18"

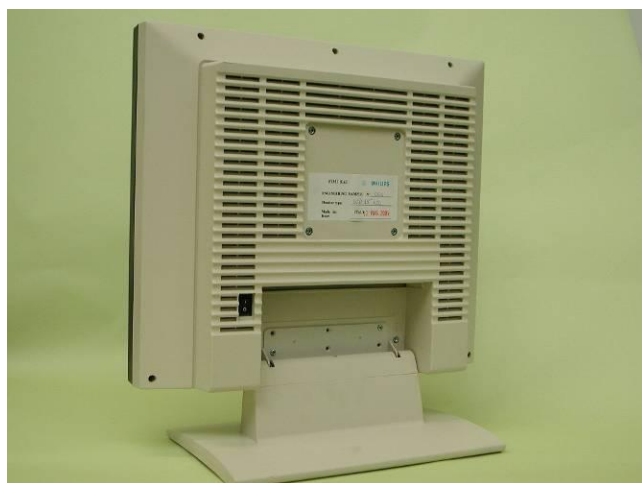
LCD screen FIMI MML1801-GX / 9919-320-5122x

To be Removed	Substances:		Location
	Type	Quantity	
	Cd	0	
	Hg	21 mg max. (Mercury is present in the backlight lamps)	Next figure (1)
	Pb	Lead is present in the soldering process of PCBs	Next figure (2.x)
	Cr ⁶⁺	0	
	PBB	0	
	PBDE	0

Material		
Fe	6 kg	-
Al	0	-
Cu	0.11 kg	Cables
Plastics	1.5 kg	-
Boards (S ² > 10cm ²)	96 cm ² / 260 g 320 cm ² / 230 g 144 cm ² / 67 g 100 cm ² / 50 g 46 cm ² / 40 g	S.M.P.S. (item 2.1 in the figure) Logic Board (item 2.2 in the figure) Inverter (item 2.3 in the figure) LCD Driver (item 2.4 in the figure) PCB Light Sensor (item 2.5 in the figure)
LCD	3.97 kg	18"

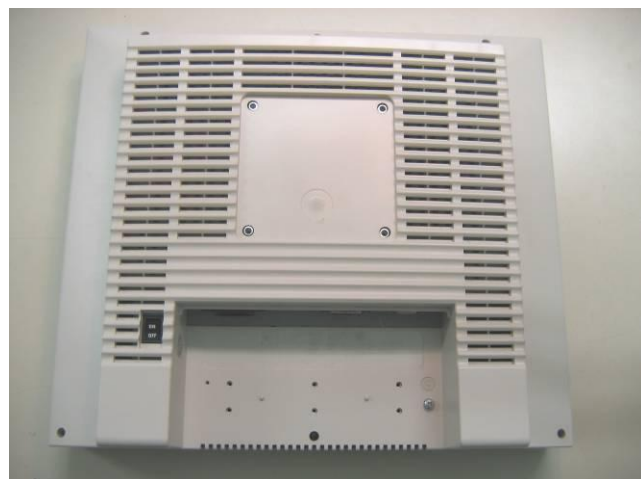
LCD screen FIMI MML1802-GXR / 9919-320-5123x

To be Removed	Substances:		Location
	Type	Quantity	
	Cd	0	
	Hg	21 mg max. (Mercury is present in the backlight lamps)	Next figure (1)
	Pb	Lead is present in the soldering process of PCBs	Next figure (2.x)
	Cr ⁶⁺	0	
	PBB	0	
	PBDE	0

Material		
Fe	2.3 kg	-
Al	0	-
Cu	0.1 kg	Cables
Plastics	1 kg	-
Boards (S ² > 10cm ²)	96 cm ² / 260 g 320 cm ² / 230 g 144 cm ² / 67 g 100 cm ² / 50 g 46 cm ² / 40 g	S.M.P.S. (item 2.1 in the figure) Logic Board (item 2.2 in the figure) Inverter (item 2.3 in the figure) LCD Driver (item 2.4 in the figure) PCB Light Sensor (item 2.5 in the figure)
LCD	3.9 kg	18"
