Recycling Passport

Product name:	MammoDiagnost analog	
Identification code	9890-010-83981	
Order No.		
Device Type	B2B (Business to business)	
Producer /Manufacturer	Company name:	Philips Medical Systems DMC GmbH
	Address:	Roentgenstrasse 24
	Zip code:	22335 Hamburg
	Country:	Germany
	Web info:	See Philips Intranet
Total weight (in Kg) thereof		453 Kg

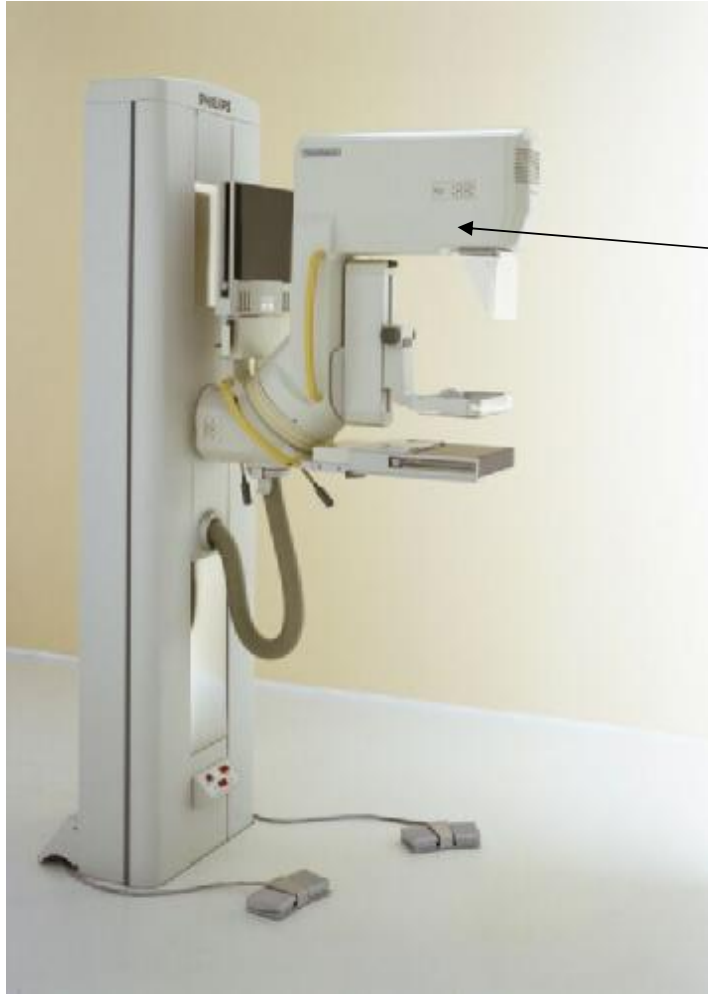
Locations as mentioned in the Passport (Pictures information)

To be removed	Substances:	Location
	Lead	Fig. 1
	tungsten	Fig. 1
	beryllium	Fig. 1
Batteries

Item	Location
	Oil tank / Remove oil before dismantling	Fig. 1
	HV-transformer oil contains no PCBs
