<b>Product name:</b>		<b>Ingenuity CT Gantry</b>
<b>Identification code(s)</b>		<b>459800029801</b>
<b>Total weight (in Kg)</b>		<b>1941</b>
<b>Producer/ Manufacturer</b>	Name company:	Philips Medical Systems
	Address:	595 Miner Road Highland Heights, Ohio
	Zip code:	44143
	Country:	United States of America

Title: Recycle Passport Ingenuity CT Gantry  
 Recycling Passport Number: 459800122671 Rev: A

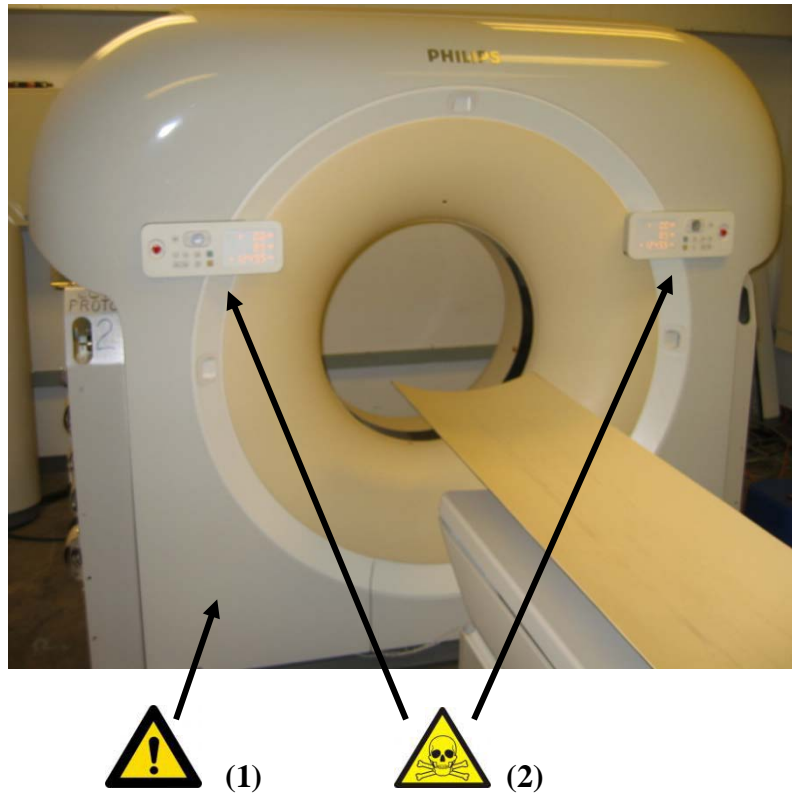
**Figure 1: Front View of Gantry with Covers on**

Spring loaded cover	Figure 1 (1)
	Actuators: Unstable when removed, possible rotation of frame	Figure 4 (2), Figure 5 (2)
	System Unbalanced when rotor components are removed causing rotation	Figure 3 (5)
<b>Fluids / Gases</b>

<b>Substances:</b>	<b>Location</b>
	Printed Circuit Boards	Figure 1 (2), Figure 2 (1), Figure 4 (1), Figure 5 (1)
	Lead	Figure 3 (1),(3),(4)
<b>To be Removed</b>

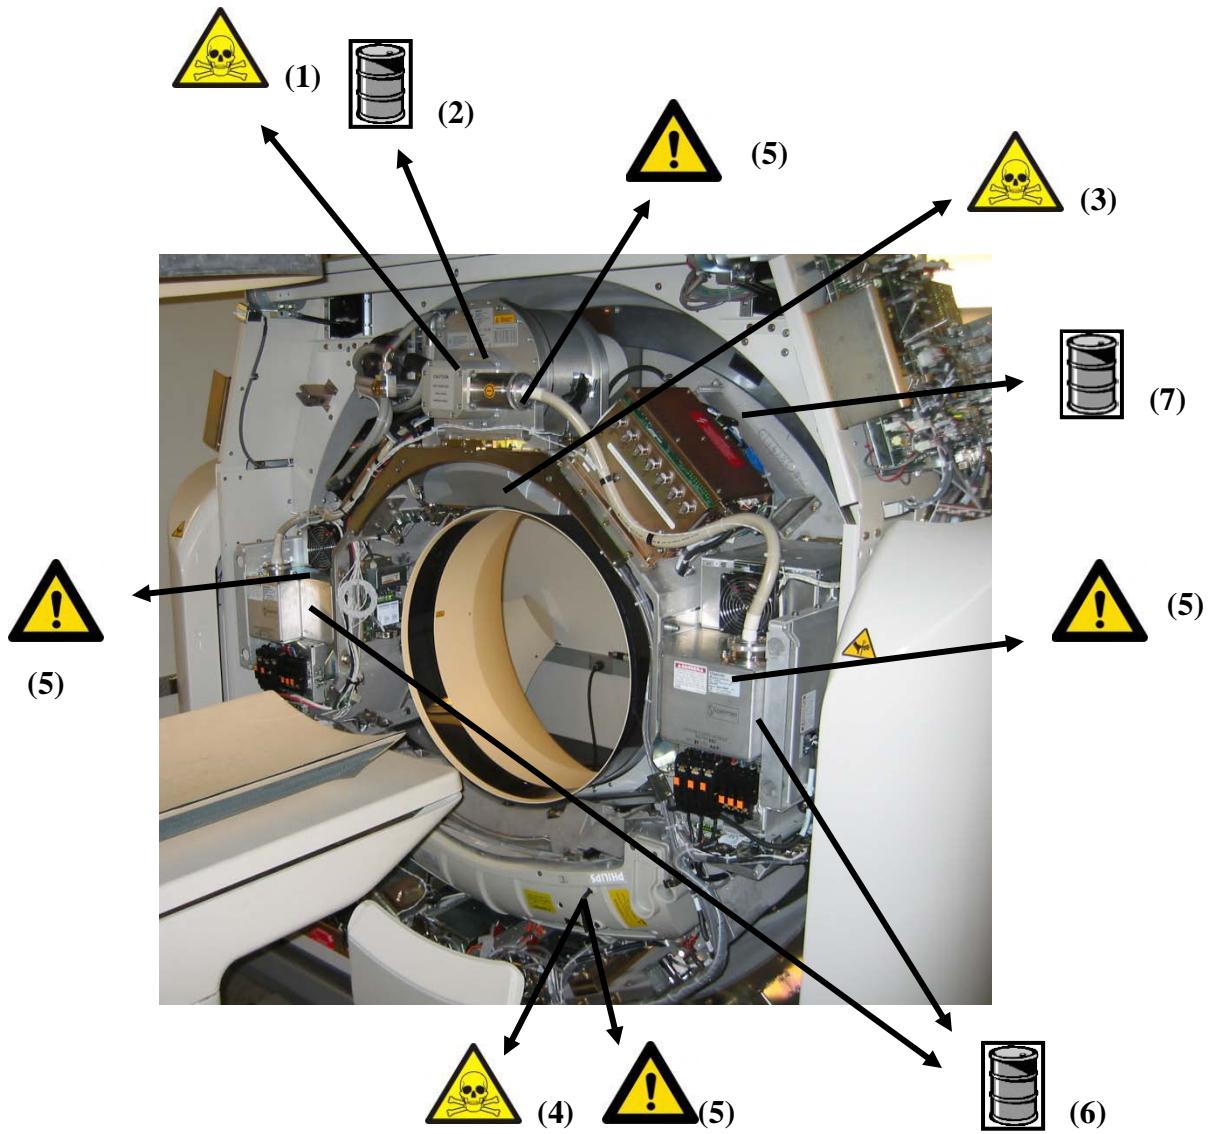
**Figure 3: Front View of Gantry with Front Cover Lifted**

<b>Items:</b>	<b>Location</b>
	X-Ray Tube Hydrocarbon Oil	Figure 3 (2)
	Generators Hydrocarbon Oil	Figure 3 (6)
	Overflow Tank Hydrocarbon Oil	Figure 3 (7)
<b>Batteries</b>
