| Product name | Recycling passport Mammotrak trolley 1.5T and 3.0T | | | | |
| Identification code(s) | 98960301987x (1.5T version) and 98960302084x (3.0T version) (where x can be any digit from 19) | | | | |
| Manufacturer | Philips Healthcare Nederland B.V. | | | | |

Recycling information

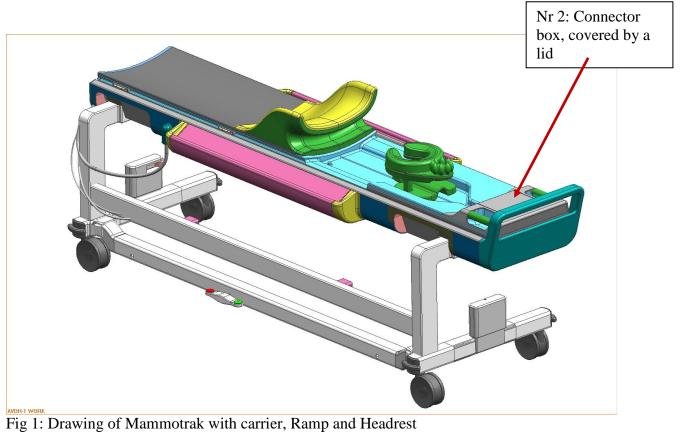
| Items | Location |
|---|--|
| An ODU connector (for the RF cable) and connectors for the nurse call and headset are positioned under the lid at the head-end of the carrier | Nr 2: Fig 1 and fig 4 |

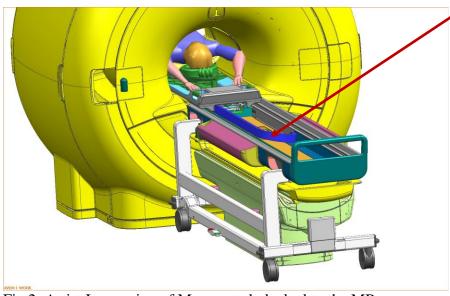
Fig 2: Artist Impression of Mammotrak docked to the MR scanner

| Items | Location |
|---|--|
| Under the carrier in the spacer there is a cable slab. An RF cable, a nurse call cable, and the headset tube run through this cable slab. | Nr 1: Figure 2 |

Nr 1: Cable slab, containing RF cable, nurse call cable and tube for headset

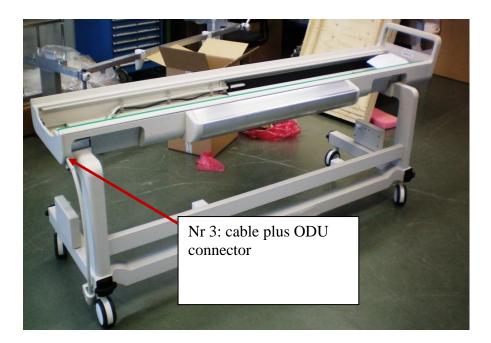
Fig 3: Mammotrak without carrier

| Items | Location |
|---|--|
| A cable plus ODU connector and connection to the headset and nurse call are at the side of the spacer. | Nr 3: Fig 3 and 4 ODU Connector: fig 5. |
